1. Kings of Rap removed hardware.

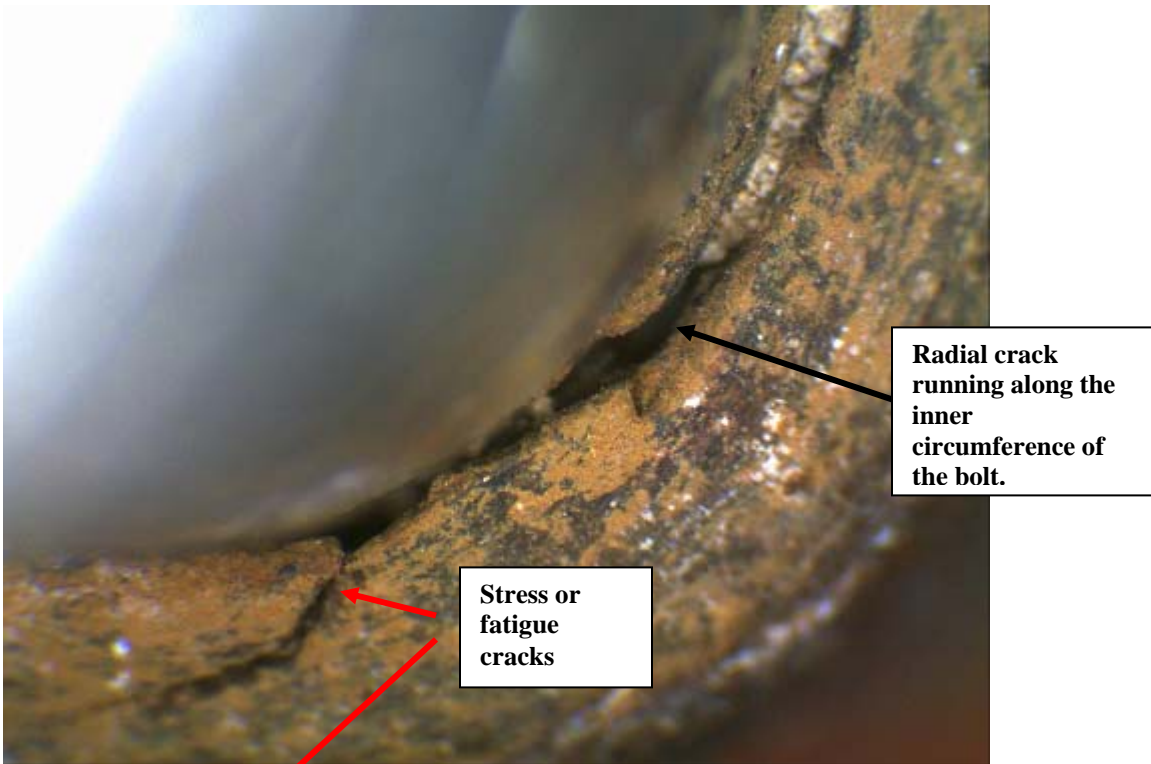
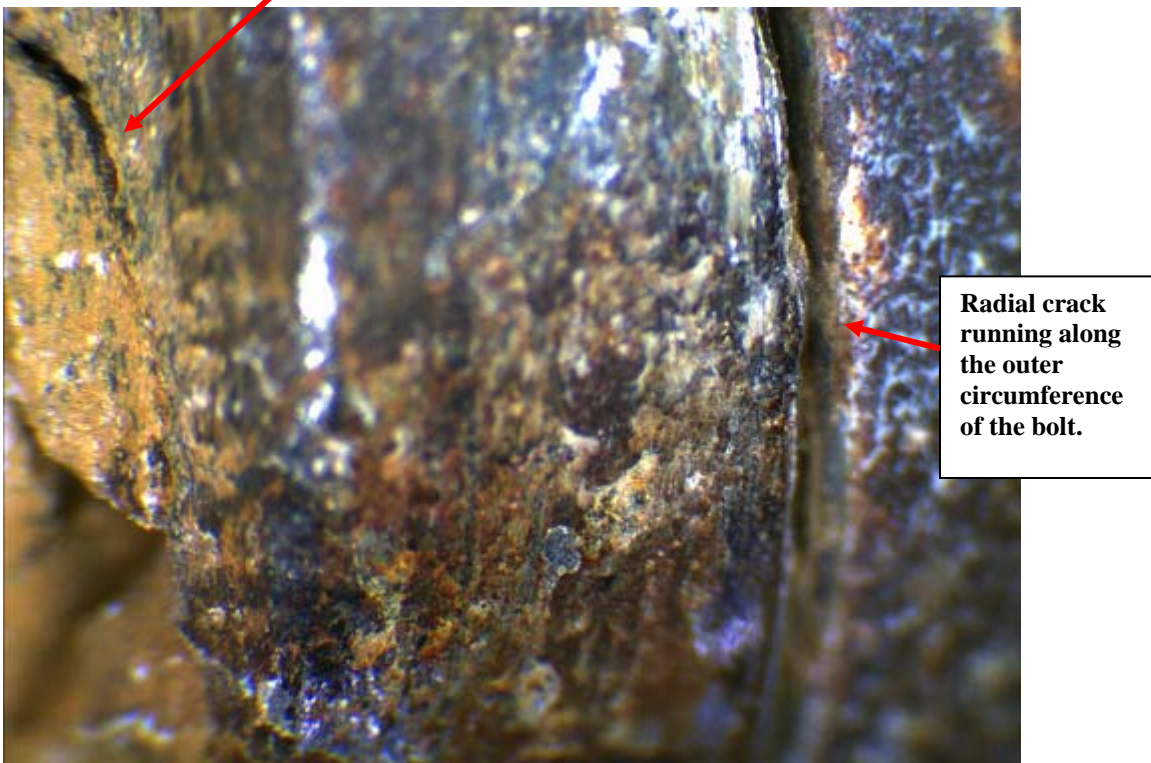
The steel studs are rusted and some show stress or corrosion cracks. The threads are very worn and one can tell from the wear locations that on some bolts only 50% of the thread was actually engaged.

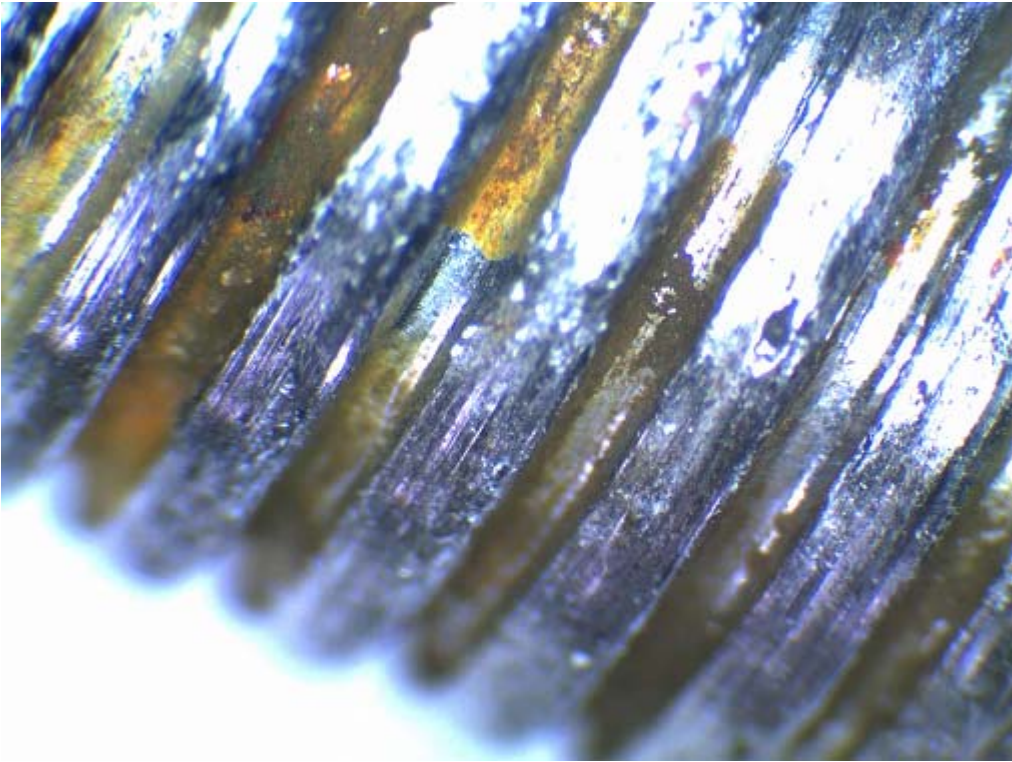
**Kings bolt
thread worn
down = less
axial pull out
strength.**

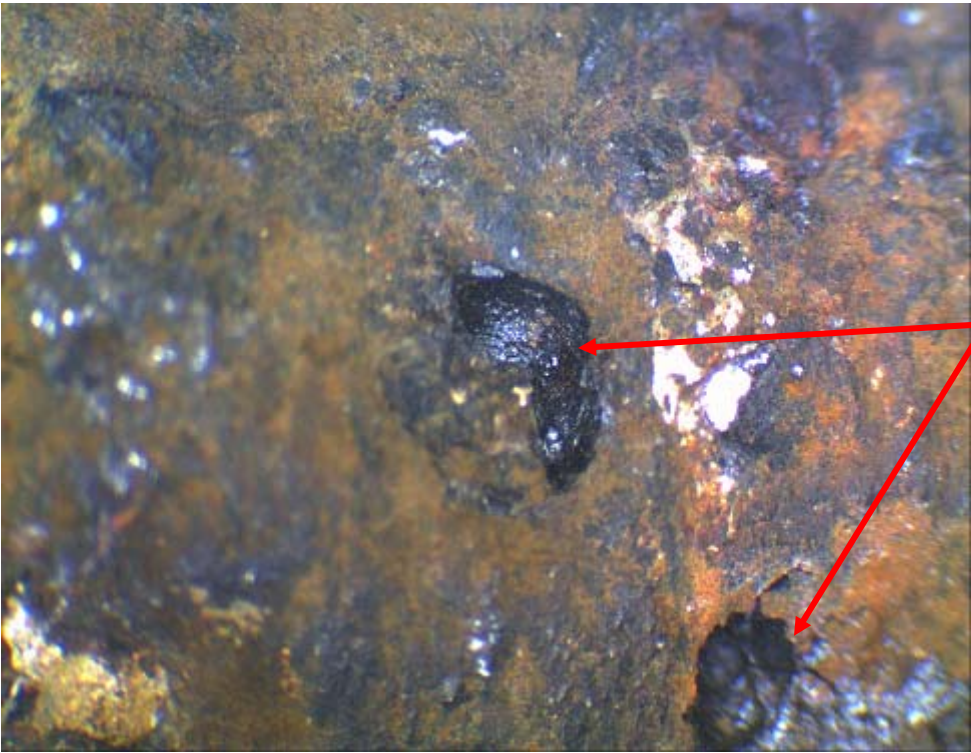
**Kings crux bolt,
significant
corrosion
damage.**

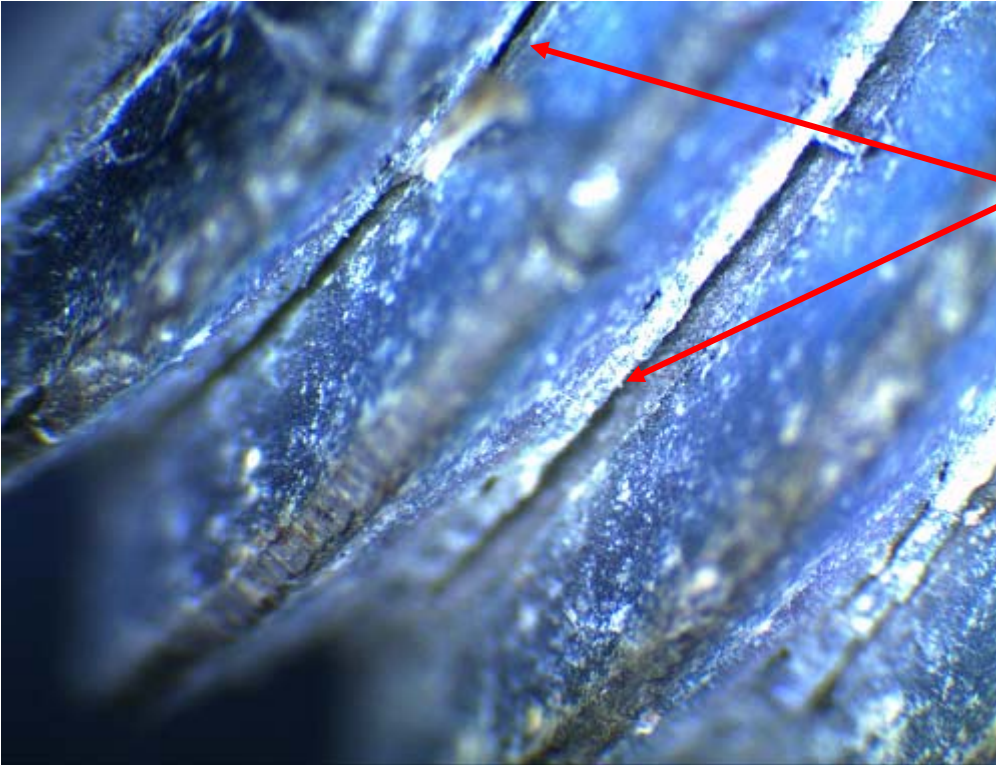
3/8" studs are in bad shape. Thread completely flattened by hanger movement under load. Significant amount of rust build up. Stress cracks close to hanger location in radial direction.

Toxic, radial stress cracks close to bolt hanger location. 3/8" stud.

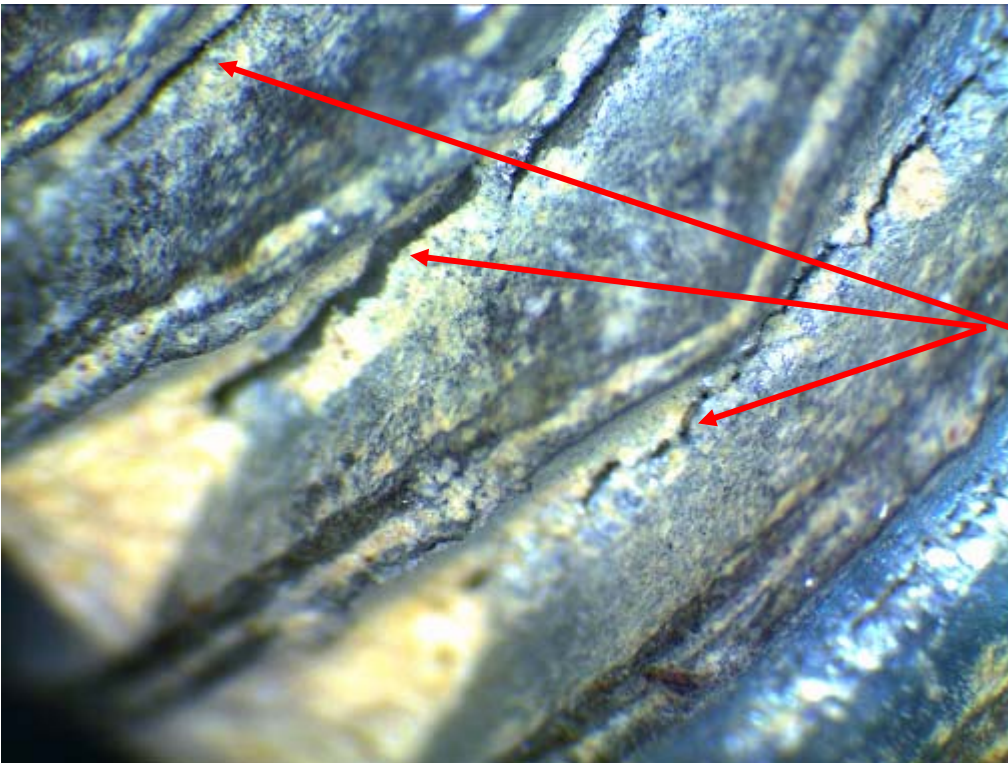
Toxic, radial stress cracks on 3/8" stud .
